PREVENTING RUNWAY INCURSIONS WITH ENHANCED AIRFIELD GEOMETRY

by Gaël Le Bris

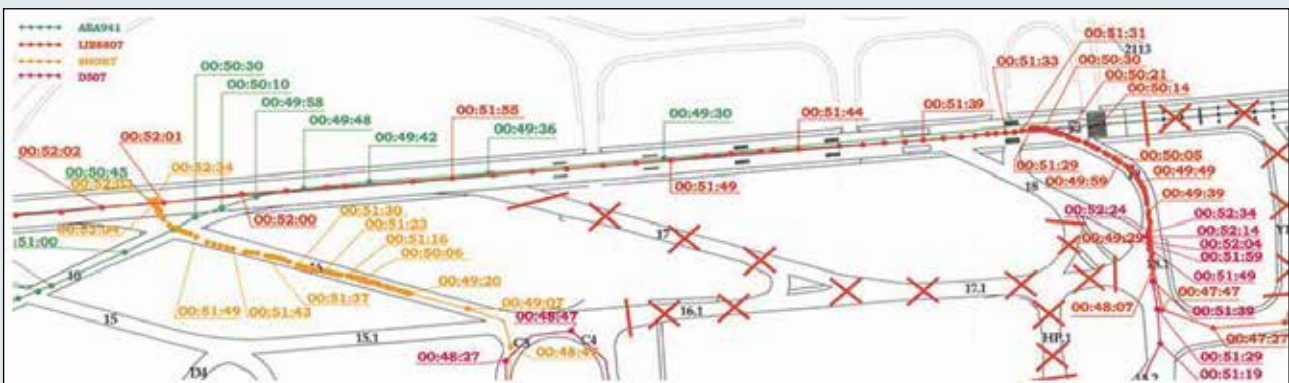
The MD83 was cleared to line up and takeoff and the Shorts 330 to line up and wait "number two". The investigation found that the controller thought both aircraft were taking off from the full length when clearing them to line up in turn. As the MD83 began to accelerate, the Shorts 330 entered the runway further along having assumed that the aircraft which had just passed them was the "No 1" taking off when in fact it was a landing aircraft. As the MD83 approached the taxiway 16 intersection and its crew saw the other aircraft, it was already beyond V1

Figure 1 – Tracks of the two aircraft which collided on 25 May 2000

and impossible to stop their aircraft before reaching the Shorts 330. The MD83 left wingtip went through the flight deck of the Shorts 330, killing the Co-pilot and seriously injuring the Pilot.

The Final Investigation Report of the BEA (the French Accident and Incident Investigation Board), gave the 'Probable Causes' of the accident as the TWR controller's erroneous perception of the position of the aircraft (reinforced by the prevailing context and working methods) which led him to clear the Shorts 330 to line up, the inadequacy of systematic verification procedures which made impossible for the error to be corrected and the crew of the Shorts not dispelling any doubts they had as to the position of the "number one" aircraft before entering the runway. One of six 'Contributory Factors' also identified was "the angle between access taxiway 16 and the runway which made it impossible for the Shorts 330 crew to perform a visual check before entering the runway".

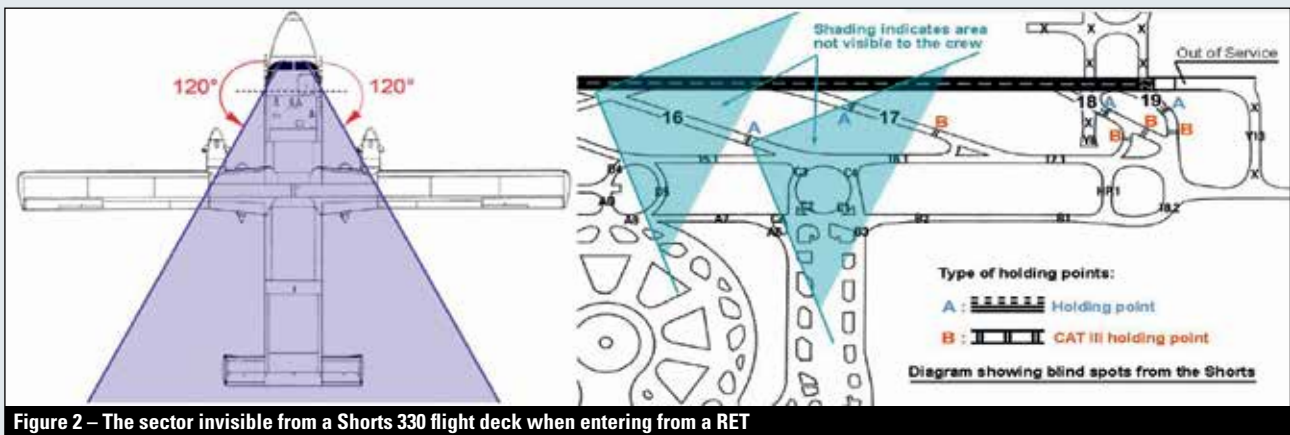
Figure 2 – The sector invisible from a Shorts 330 flight deck when entering from a RET

After the accident, the Air Traffic Control Tower (ATCT) decided to ban line ups from any RET⁶.

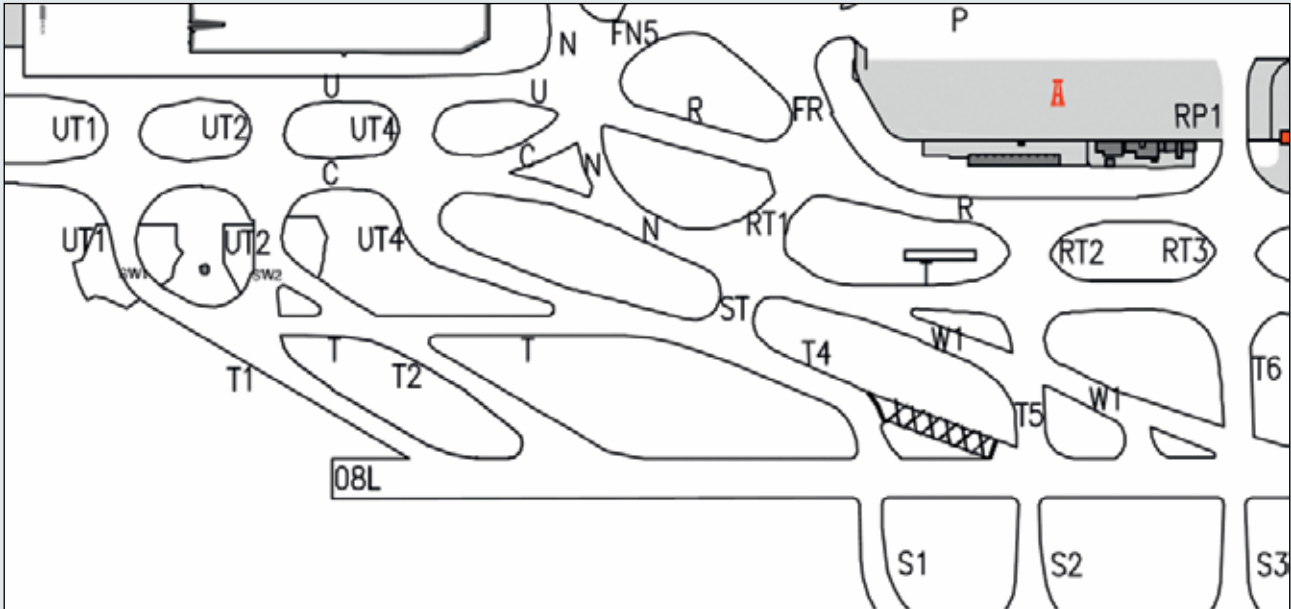
This accident was also one of the influences on a large scale taxiway reconfiguration project around Threshold 08L. Between 2011 and 2014, more than 3 hectares of taxiways were reconfigured. While this work was not wholly motivated by runway safety concerns, one of its objectives was to help prevent an accident similar to the collision of May 2000. The threshold area of southern runway 08L was the only one not reconfigured with 90° access taxiways at that time. Taxiways W1 (now T1), WB (now T2), W1 (no longer exists) and the original W2 (now W1) all retained an acute angle recognised as conducive to hazardous runway entry.

**Figure 4 – Configuration of Threshold 08L in 2011 before the construction works
Note the closure of the angled access between T4 and T5 (ex-W1)**

It was therefore decided to redesign this area. The changes took place over a 4 year period and introduced a new 90° access (T3) and made the other main access taxiways (current T2 to T6) straight or straighter. They also improved the intersections around the former "KILO loop", preventing confusions between taxiways W1 (ex-W2) and TANGO when turning counter clockwise on the loop.

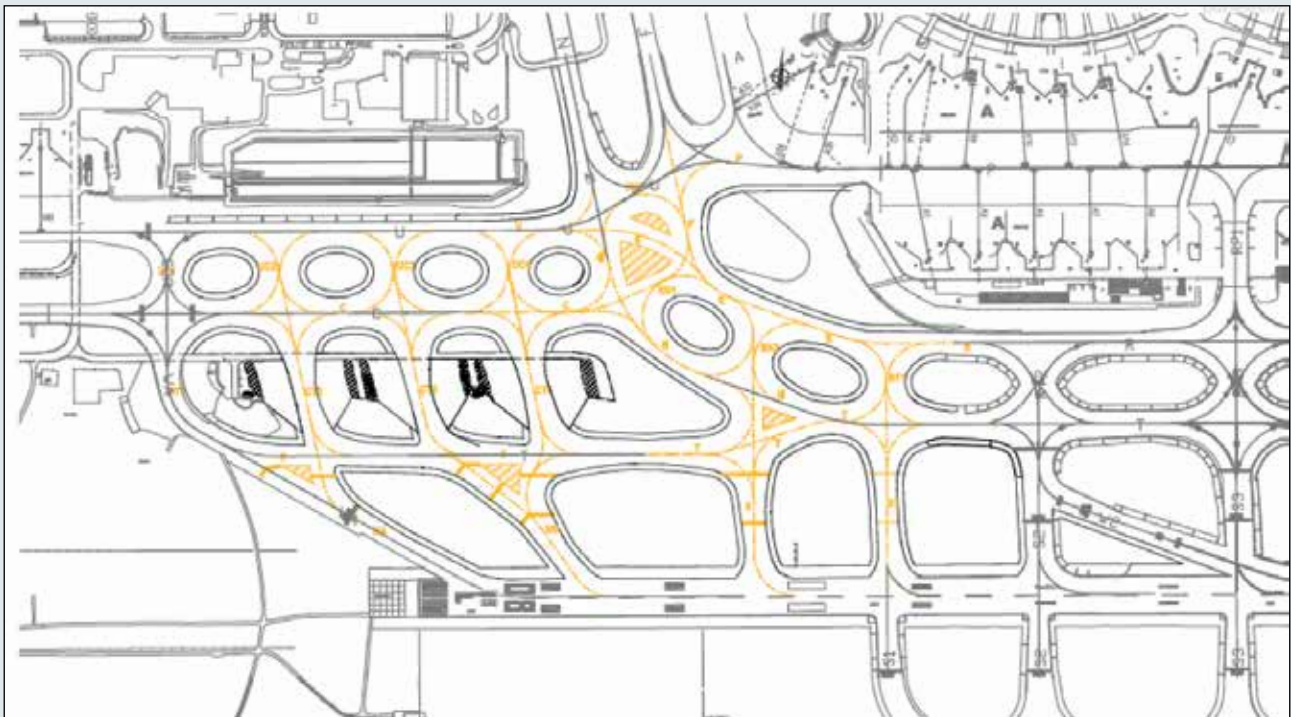
Figure 5 – Configuration of Threshold 08L in 2014 after the construction works

Due to the topography, it was decided that it was not practical to make taxiway T2 a 90° access without compromising the longitudinal slope and the connections from de-icing pads SW1 and SW2. But it was realigned to increase its angle to the runway from 30° to approximately 55° to make a pre-entry visual check of the 08L approach by pilots practicable.

The final configuration of these access taxiways left 'islands' between taxiway TANGO and taxiways T1 and T2. The main concern was reduce the risk of an aircraft taxiing in the middle not seeing the CAT III stop bar or misunderstanding of the switching off of the entire bar if two aircraft were holding the CAT III holding position at the same time. After considering and consulting on different options with the airside community (e.g. LRST), it was decided to remove the marking and lighting of the holding position between the two entries to T1 and T2 and in both cases to extend the unavailable area markings (yellow hatching) as far as practicable (option N°2). The paths were delineated with blue taxiway edge lights. This final configuration is similar to FAA practices for islands between multiple runway entrances⁹.

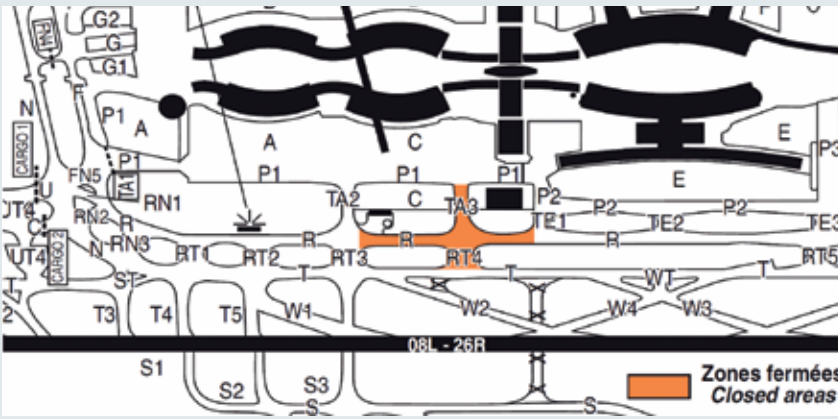
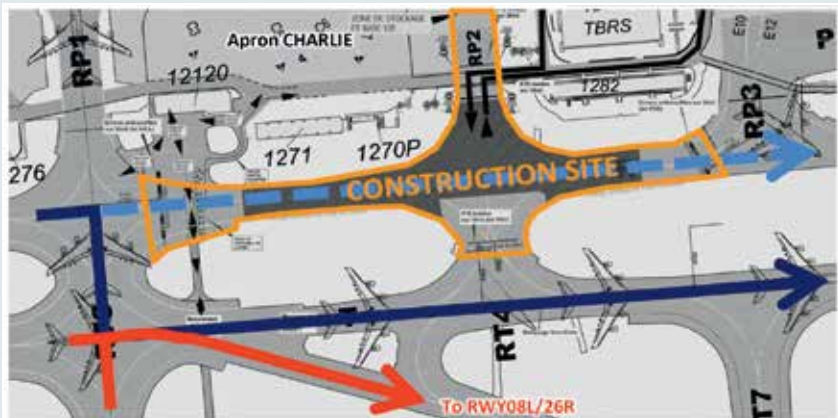
From a pilot and air traffic controller perspective, aerodrome layout should be carefully considered when preparing for a construction project which will modify taxi routings and may increase existing runway incursion and collision risks or create new ones. At Paris-CDG, the rehabilitation of taxiway ROMEO south of apron CHARLIE during the autumn of 2015 raised concerns about the potential for runway incursion via RET W2 by aircraft taxiing east around the closed section of the taxiway on taxiway TANGO (see the illustrations above) Controllers were informed about this risk and the Orange Construction Signage (OCS) jointly developed by the FAA and Paris-CDG for this purpose¹¹ was used to increase pilots' situational awareness. Since 2014, this signage has been deployed at various airports in both the United States and Europe.

Figure 9 – Rehabilitation of taxiway ROMEO in 2015

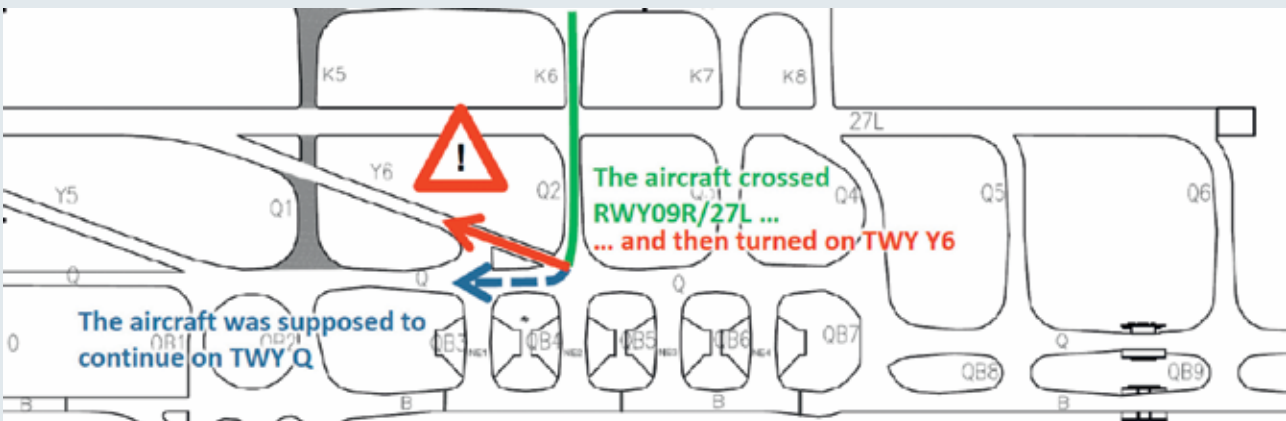
The concern about this risk had been founded on a previous incident in October 2007 when a Boeing 747 which had just landed on runway 09L and crossed runway 09R then turned onto RET Y6 from taxiway Q2 instead of continuing as cleared on taxiway QUEBEC.

Figure 10 – The erroneous routing which led to a RET incursion in 2007
