TCAS II and VFR traffic

VFR traffic transponder mode and TCAS II alerts

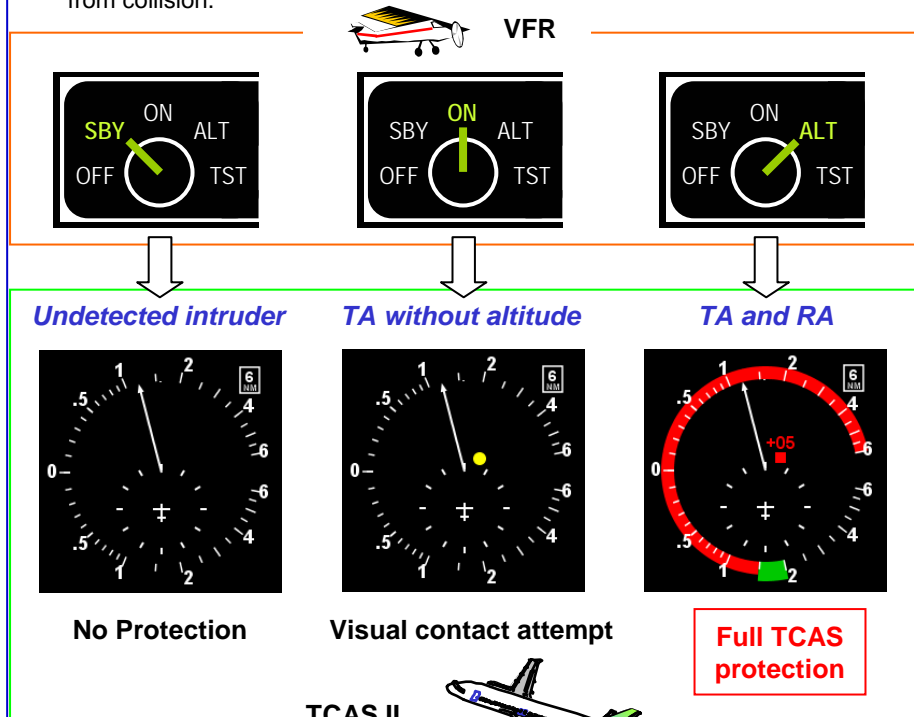
The alerts triggered by TCAS II depend on the transponder mode of the intruder.

- "OFF" or "STAND-BY": TCAS II cannot detect the intruder and therefore there is no alert at all.
- "ON", i.e. without altitude reporting: TCAS II will only generate a Traffic Advisory (TA) to help the pilot achieve visual contact. However, the TA is unable to show whether the aircraft are at the same altitude or not!
- "ALT": TCAS II can trigger TAs and Resolution Advisories (RAs). An RA, if followed, protects the VFR traffic as well as the traffic equipped with TCAS II from collision.

For maximum safety benefit from TCAS II,
VFR traffic must squawk altitude

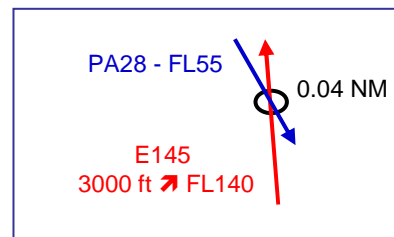
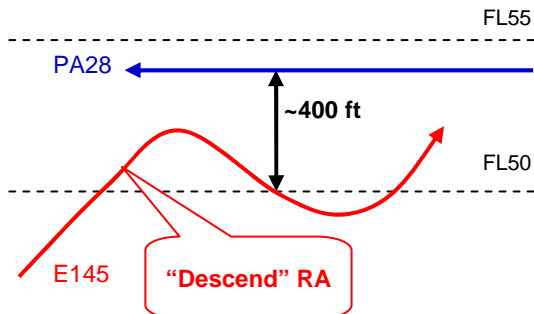
Event 1: TCAS resolution between IFR and VFR traffic in Class D

A PA28 flying VFR is transiting a TMA, in Class D airspace. It is level at FL55 (mode C reports show FL54).

An E145 is climbing on departure, on a reciprocal heading, passing 3000 ft.

The E145 is cleared to climb to FL140 by the Approach controller and "to expedite through 5500 ft due to VFR traffic at 12 o'clock, 10 NM, opposite route".

The controller also provides traffic information to the PA28 about the E145, "12 o'clock, opposite route, passing your altitude". Then, he provides further traffic information to the E145 (traffic at 12 o'clock 4 NM). About 15 seconds later, the E145 receives a "Descend" RA, when passing FL51. The pilot follows the RA correctly and initiates a descent.

As a result of following the "Descend" RA, the E145 passed about 400 ft below the PA28. Simulations indicate that **without TCAS the separation between the aircraft would have only been about 100 ft and 0.04 NM.**

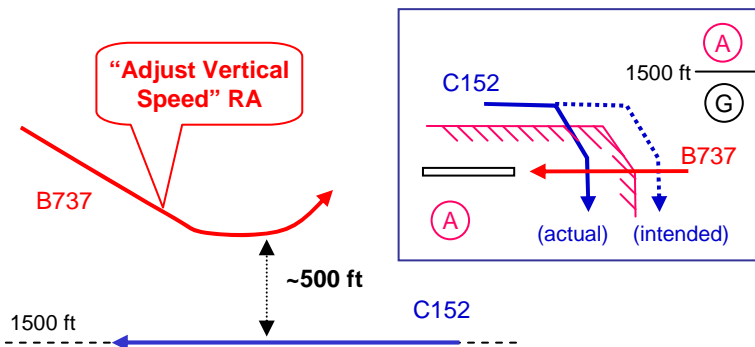
Event 2: VFR traffic penetrating Class A

In Class A airspace, a B737 is descending on the glide path for the final approach.

Due to a navigation error, a C152, flying VFR and level at 1500 ft QNH, is crossing the ILS axis at 4 NM from the runway threshold instead of at about 10 NM. The C152 has an **active altitude reporting transponder**.

The B737 pilot gets visual contact on the VFR traffic and continues the approach. As it passes through 2000 ft, the B737 receives an "Adjust Vertical Speed" RA.

In response to the RA, the pilot stops the descent and then initiates a go-around. The vertical distance between the aircraft is about 500 ft.

Simulations show that if the B737 had continued the descent, **the separation would have been less than 300 ft and 0.08 NM.**

To improve flight safety, VFR traffic should operate an altitude reporting transponder in all airspace classes, including Class G.

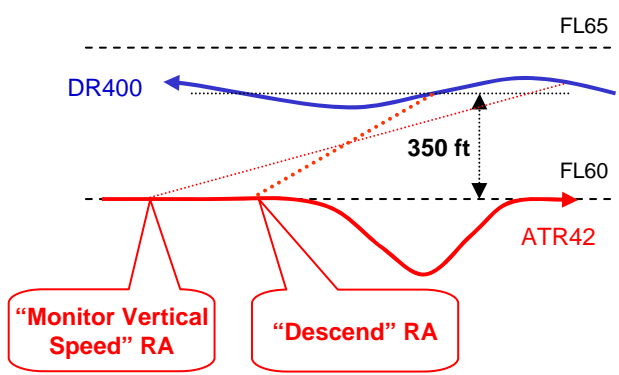
Event 3: IFR and VFR traffic crossing at 500 ft

In Class D airspace, an ATR42 is held at FL60 after departure, heading east, against a VFR DR400, on a reciprocal track, supposedly "level" at FL65.

The DR400 is not maintaining level flight and its altitude is actually **oscillating** between FL63 and FL64.

Shortly after levelling off, the ATR42 receives a **"Monitor Vertical Speed"** RA to prevent further climb when the DR400 is 2.20 NM ahead and 400 ft above.

Subsequently, the RA is strengthened into a **"Descend"** RA when the vertical separation between the aircraft becomes less than 350 ft. The pilot follows the RA and descends to FL57 before climbing back to FL60.

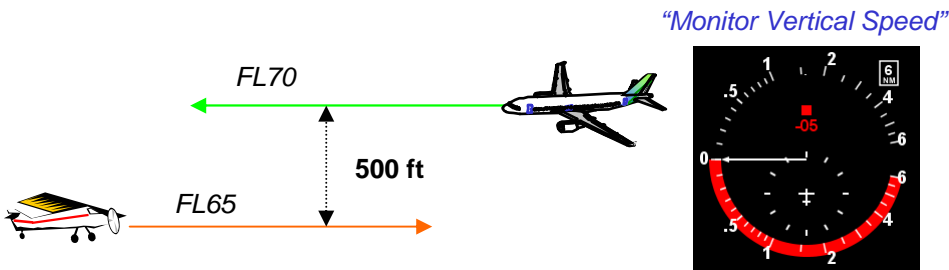
In both Class D and Class E airspaces, a frequent encounter between IFR and VFR traffic is when **both aircraft are level and "separated" by 500 ft**. In these encounters, TCAS will generate a "Monitor Vertical Speed" RA, which does not require a vertical deviation.

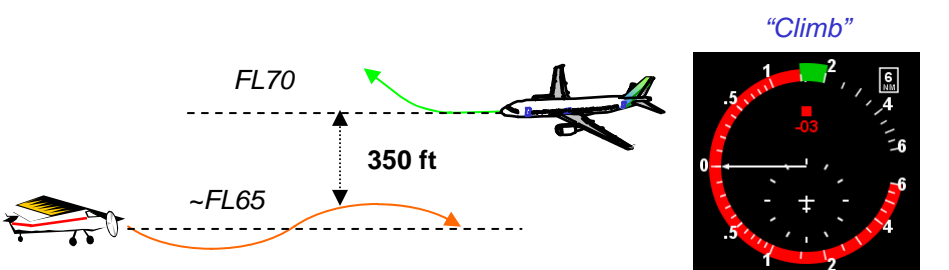
Operational experience shows that **VFR traffic sometimes do not maintain level flight perfectly**. If there is a significant vertical deviation, "Climb" or "Descend" RAs will be generated on-board the TCAS-equipped aircraft.

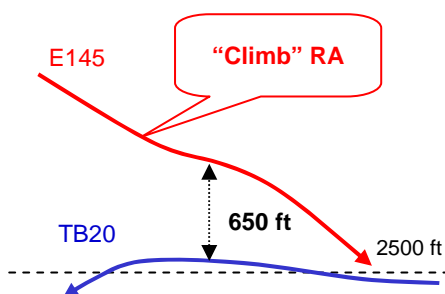
Event 4: VFR in the aerodrome traffic pattern

An E145, on approach in Class D airspace, is cleared to descend to 2800 ft QNH and to intercept the glide path.

A TB20, flying VFR and in radio contact with another controller, is crossing the runway centreline cleared at 2000 ft QNH. However, the pilot has entered the wrong altimeter setting and is actually at 2500 ft QNH.

The controller instructs the E145 to stop its descent at 3500 ft and provides a traffic information about the VFR. Because the pilot reports visual contact on the VFR, he is cleared to continue the descent on the glide path. However, the E145 then receives a "Climb" RA triggered by the TB20, which is crossing directly underneath his track.

The E145 pilot responds slowly to the RA, reducing the rate of descent. Although not achieving a rate of climb, he passes the VFR traffic at 650 ft and no more than 0.2 NM.

In this event, the high risk of collision resulting from an undetected altimeter setting error was resolved by TCAS, even though the pilot of the E145 did not achieve the vertical speed required by the RA.

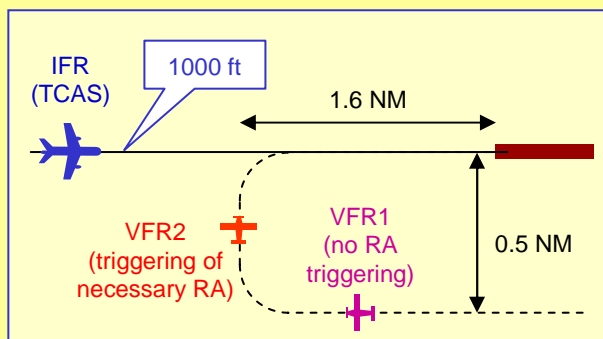
In the example shown in the diagram below, provided that the lateral distance between the final approach path and the downwind leg is at least 0.5 NM, the VFR traffic on the downwind leg (VFR1) will not trigger an RA on board the TCAS-equipped IFR traffic on the final approach. (In addition, TCAS does not generate any RA below 1000 ft.)

If the IFR on the final approach receives an RA, this confirms that the separation with the VFR traffic on the base leg (VFR2) is inadequate.
